**TFAI Appendix 1: Form for Submission of Information on a Proposed Crossing**

**Publication Date: March 30, 2021** **Road ID: Dunmore 171, Network Name: Watabeag Road**

Timiskaming Forest - S.F.L. # 542247 Proponent: Timiskaming Forest Alliance Inc. 22 Paget Street New Liskeard, Ontario POJ 1P0 (705) 680-0033 ext. 0222 Plan Term: 2021-2031 AWS Year: 2021-22	Fisheries Operational Management Zone (OMZ): Standard for Self-assessed Water Crossing Construction, Removal and/or Decommissioning: <b>Conditions of standard not met. See red text.</b> Previous Assessment Year (incl. SA): <b>2021</b> SAR species likely to be impacted: <b>NO</b> Preconstruction photos available: <b>NO</b> Within 500m of Brook Trout stream: <b>YES</b>
---	--

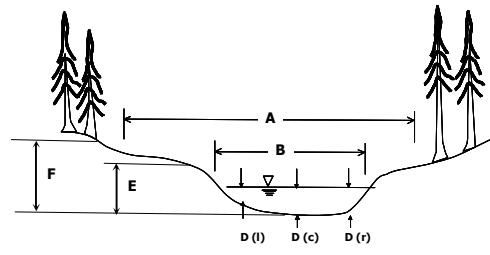
Stream Measurements (meters)	
Flood Plain Width :	A
Bankful Width :	B
Channel width :	C
Depth - 25% of Channel :	D (l)
Depth - 50% of Channel :	D (c)
Depth - 75% of Channel :	D (r)
Depth - Bankful Flow :	E
Depth - Floodplain :	F
Stream Velocity :	_____ m/sec

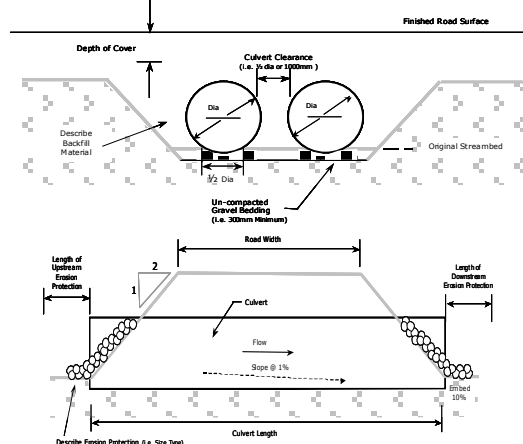
* 'As Built' Culvert Installation Measurements (meters)	
Installed Diameter :	_____
Structure Length :	_____
Road Width :	_____
Depth of Cover:	_____
Water Depth in Pipe :	_____
Number of Culverts :	_____
Spacing Between Pipes :	_____

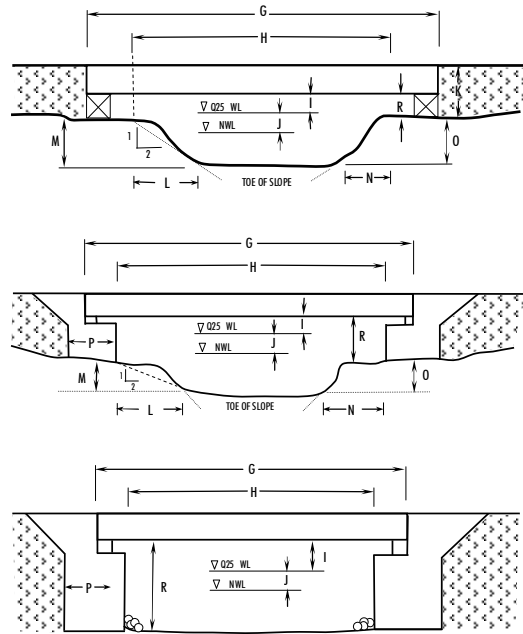
* 'As Built' Bridge Installation Measurements (meters)	
Bridge length :	G
Clear Opening Width :	H
Freeboard (min 0.5m) :	I
Flood Rise :	J
Fill Height :	K
Left Slope Length :	L
Left Slope Rise :	M
Right Slope Length :	N
Right Slope Rise :	O
Crib Width :	P
Crib Height :	R
